Electrochemical Sensors for Nondestructive Evaluation of Adhesive Bonds

Final Report STTR Contract F49620-98-C-0072

G.D. Davis and L.A. Krebs

DACCO SCI, INC.
10260 Old Columbia Road
Columbia, MD 21046
gddaccosci@aol.com
<http://members.aol.com/gddaccosci>

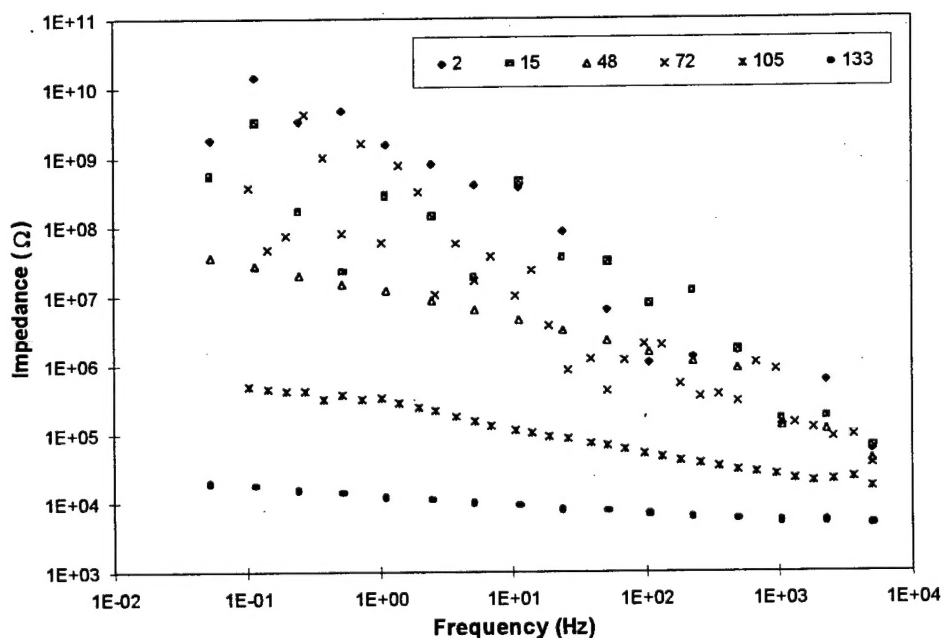
A typical series of impedance spectra for the tensile button tests is given in Figure 1. Initially, the spectra are capacitive in nature (slope of -1 on the log impedance vs log frequency graph) with high impedance at low frequencies. This behavior is similar to that of a good protective coating and reflects a polymer with no pathways of low resistance. As the adhesive absorbs moisture, the low-frequency spectrum decreases in impedance and becomes resistive or independent of frequency. This behavior reflects moisture ingress into the pores of a polymer and formation of pathways of relatively low resistance. It is typical of a protective coating in the process of degradation. The decrease of the low-frequency impedance for this specimen is shown in Figure 2 and reflects the absorption of moisture. This specimen exhibited a fairly steady impedance decrease (aside from one measurement which might be an artifact). Other specimens exhibited smaller decreases or a plateau, depending on microdifferences in the humidity chamber or small differences in the specimens. For these measurements, the data are dominated by the region of the specimen with the lowest impedance. In this case, the data represent the impedance of the near-edge region of the bondline where moisture saturation first occurs.

Figure 1. Impedance spectra for a PAA tensile specimen with one of the largest uptakes of moisture. The number of days is given in the legend.

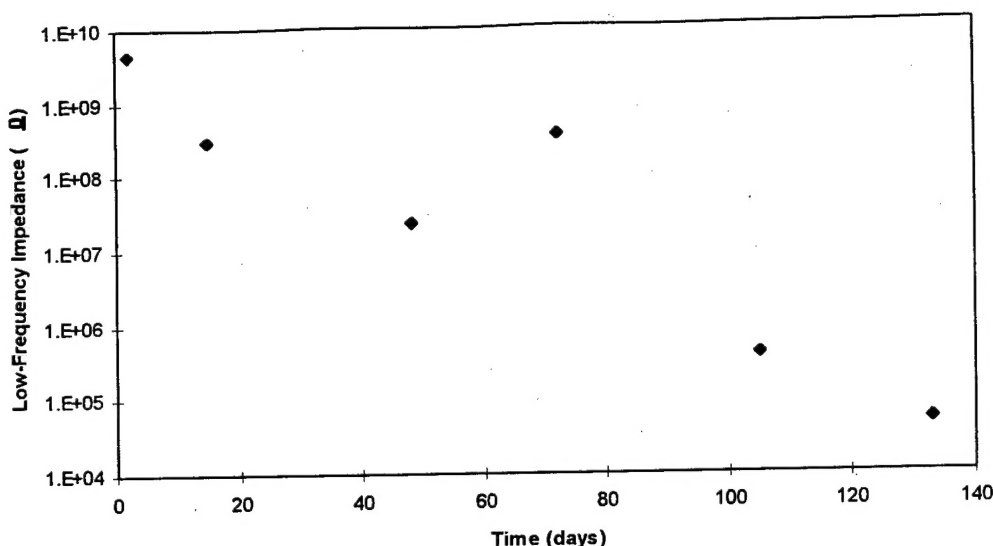
Figure 2. Geometric mean of the low frequency impedance as a function of exposure time for the PAA-treated button pull specimen of Figure 1.

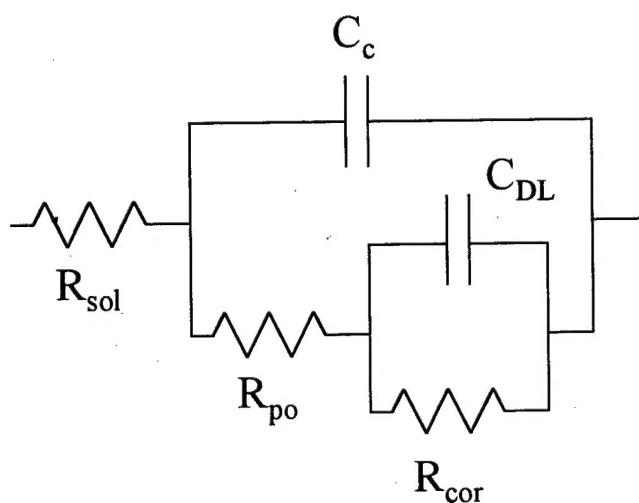
The EIS spectra can be modeled with an RC circuit, such as the typical coated metal circuit of Figure 3, where R_{po} and C_c represent coating properties, R_{cor} and C_{DL} represent interfacial properties, and R_{sol} represents the solution resistance (not relevant in this case). The dry specimen would have a very high R_{po} value so that C_c dominates the spectrum. As moisture is absorbed, the R_{po} value would decrease by several orders of magnitude and begin to dominate at low frequencies when the impedance associated with C_c is very high. The C_c value would also increase (the impedance associated with the capacitor would decrease), but on a much smaller scale, because of the larger dielectric constant of water compared to the adhesive. Initially, the interfacial parameters would remain unchanged. These parameters would reflect adherend hydration or other interfacial reactions once they occur.

Figure 3. Typical equivalent circuit for a coated metal.

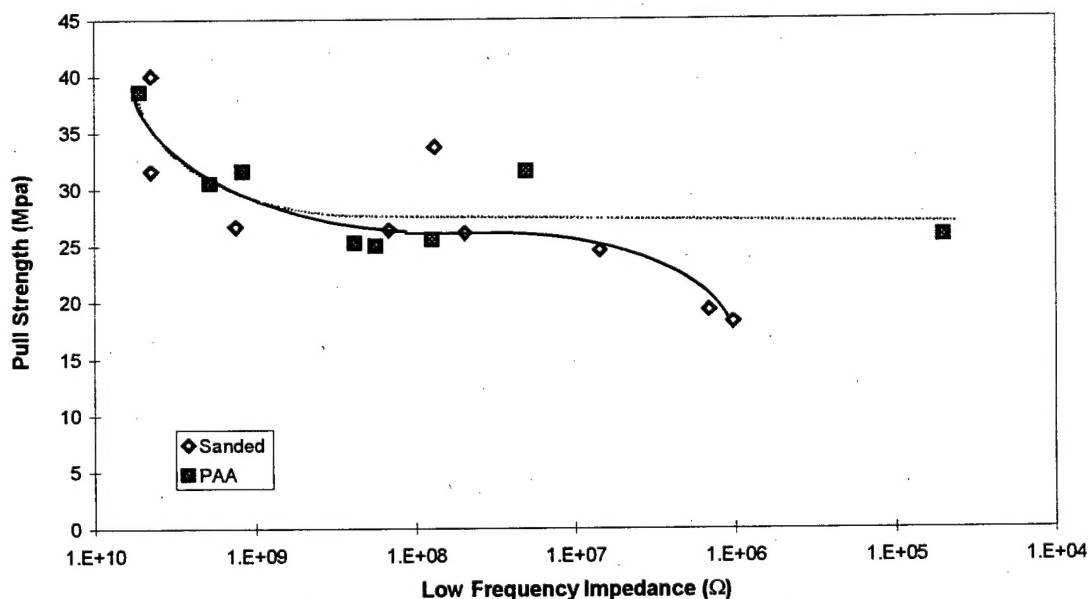
The effect of this moisture absorption on the tensile pull strength strongly depends on the surface treatment. This dependence is illustrated in Figure 4. The initial decrease in pull strengths from approximately 38 MPa to 27 MPa corresponds to a decrease in the cohesive strength of the adhesive as moisture is absorbed. For PAA specimens, the length of time available for this experiment (approximately five months) under these conditions (humidity, followed by immersion) was insufficient to induce hydration. Accordingly, the microcomposite interphase formed by the porous PAA oxide²² and the adhesive remained stable and stronger than the cohesive strength of the adhesive so that failure was almost entirely within the adhesive (Figure 5). Similar behavior was also observed for grit blasted and FPL-etched specimens (Figure 6), with the exception of an FPL surface at the end of the experiment where the strength decreased by approximately 50% and partial interfacial failure occurred. XPS analysis of the interfacial region of this specimen showed that, where failure was interfacial, hydration had occurred under the adhesive. In contrast, because the sanded surfaces exhibit no evolved microroughness, their bonds to the epoxy adhesive rely more on secondary bonds, such as van der Waals forces, which are readily disrupted by moisture. The locus of failure gradually shifts to increasingly more interfacial with the interfacial region beginning along one segment of the edge and growing along the circumference and toward the center. Although the interface is weakened considerably by the moisture, it still retains some strength as indicated by Figure 7 where the extrapolated pull strength at 0% cohesive failure (100% interfacial failure) is approximately 15 MPa. By comparison, the dry interfacial strength must be at least 40 MPa or else the interface would be the weakest link of the bond.

Figure 4. Tensile pull strengths as a function of low-frequency impedance for PAA and sanded aluminum surfaces.

the end. For these specimens, moisture has to diffuse into the adhesive from the edges without scrim cloth or other medium that might aid moisture ingress. The first effect of the moisture is to weaken the adhesive and this was observed for all surface treatments (Figure 4 and Figure 6).

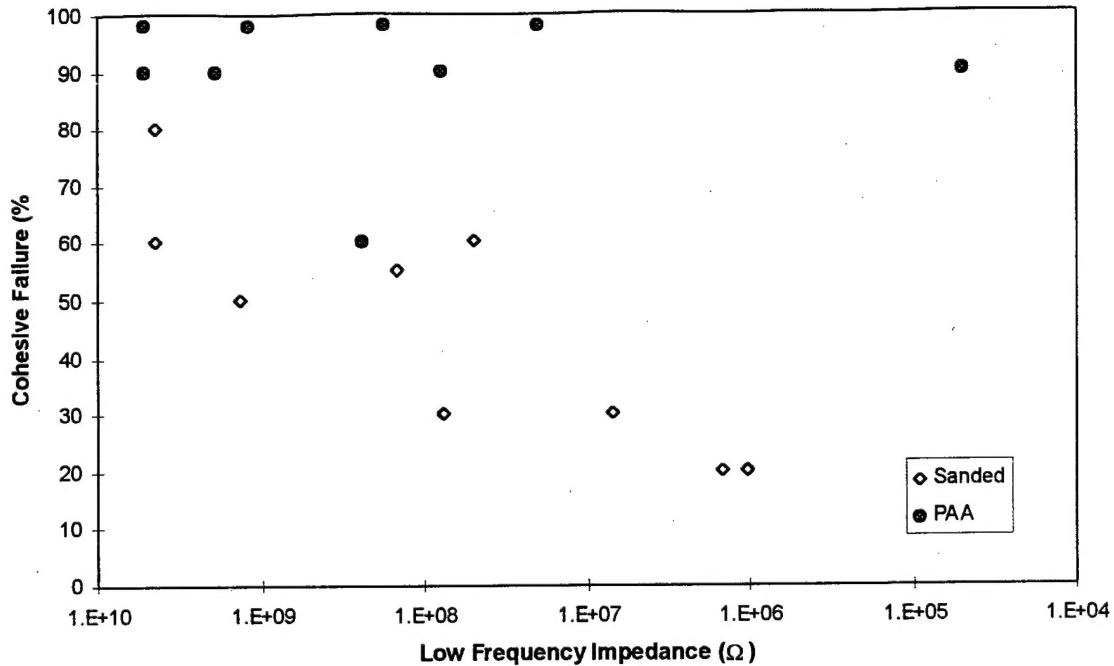
Figure 5. Percentage of cohesive failure in the adhesive as a function of low-frequency impedance for PAA and sanded aluminum surfaces.

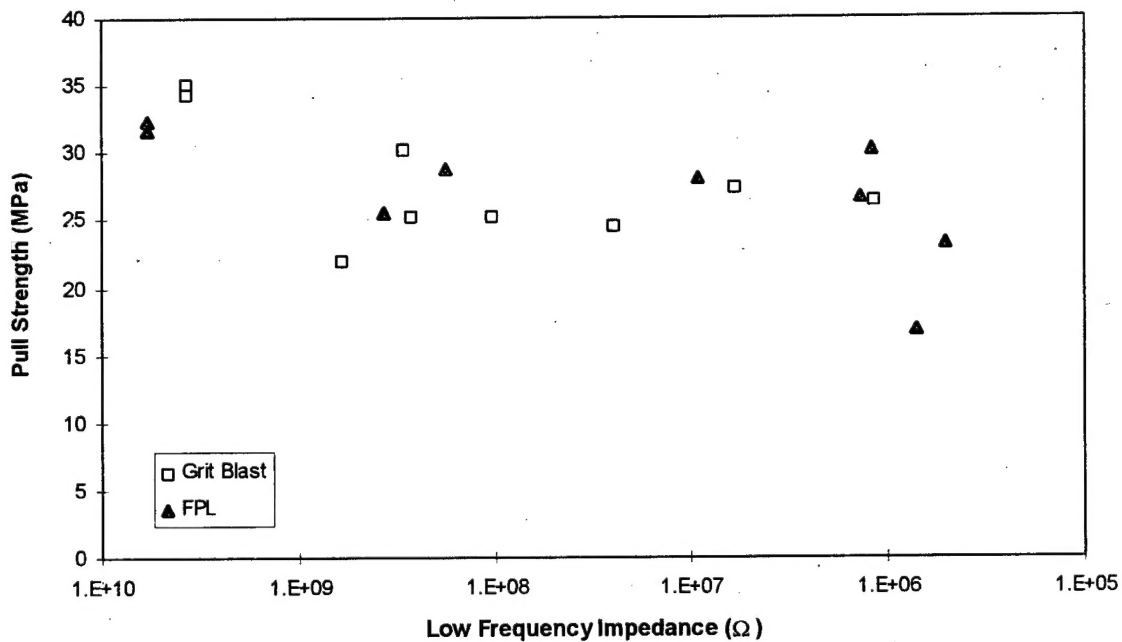
Figure 6. Tensile pull strength as a function of low-frequency impedance for grit blasted and FPL-etched aluminum surfaces.

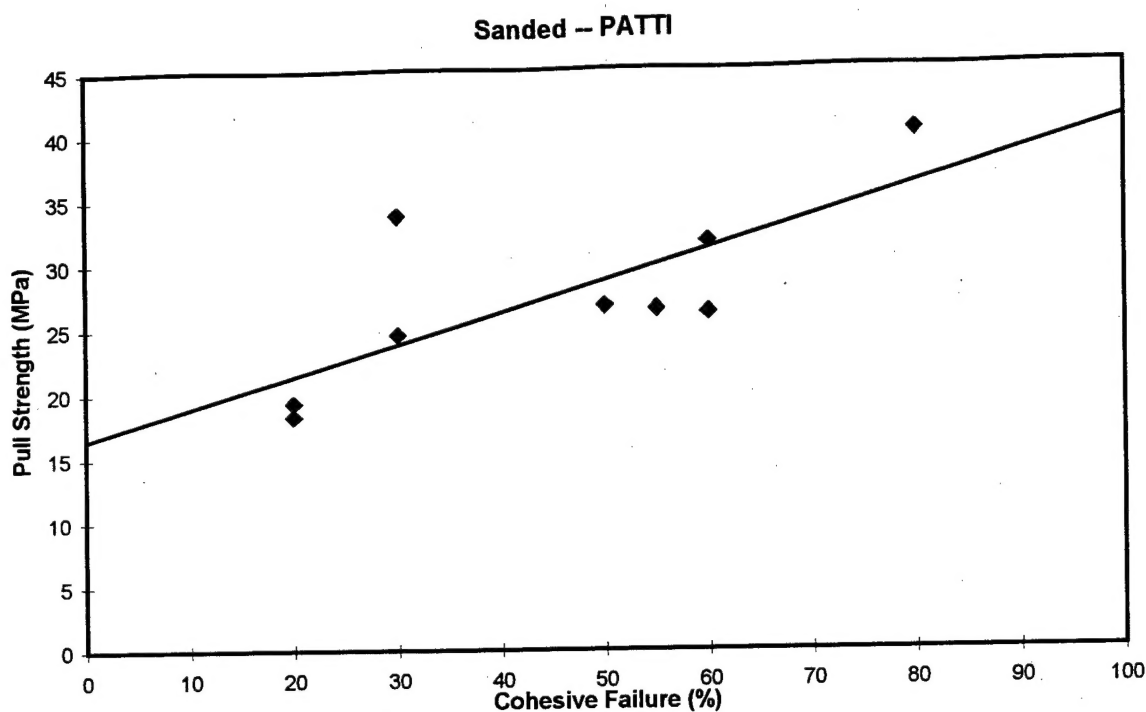
Figure 7. Tensile pull strength as a function of percentage of cohesive failure for sanded aluminum surfaces.

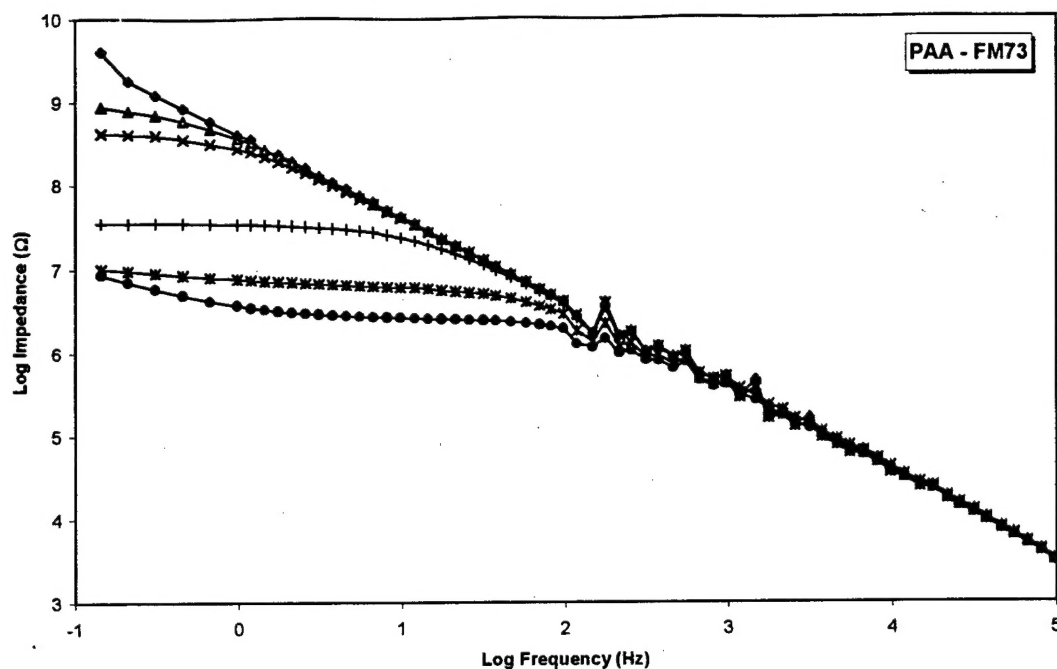
Joints tested in the wedge test configuration exhibit similar behavior to the PATTI specimens as indicated in Figure 8. Initially, the adhesive shows completely capacitive behavior. As moisture is absorbed, the low-frequency region of the spectra becomes resistive in nature with the extent of the resistive region generally increasing in frequency extent as more moisture is absorbed. The geometric mean of the low frequency impedance is given in Figure 9. Although there is considerable scatter, the data show a two-decade decrease in the low-frequency impedance between 100 and 200 hours as the adhesive absorbs moisture. Because the moisture uptake is governed by the adhesive, there is little or no dependence on surface preparation. The PAA specimens consistently exhibit slightly lower impedance than the other two treatments. This may be reflective of the lower crack length of the PAA specimens. At small crack lengths, the adhesive at the crack tip is subject to tensile stresses that increase the free volume of the polymer and allow more moisture absorption. An even greater dependence of the impedance (moisture absorption) on crack length was previously observed.¹⁶

Figure 8. EIS spectra of a PAA wedge test using FM-73 adhesive. The humidity exposure ranged from 0 to 430 hours.

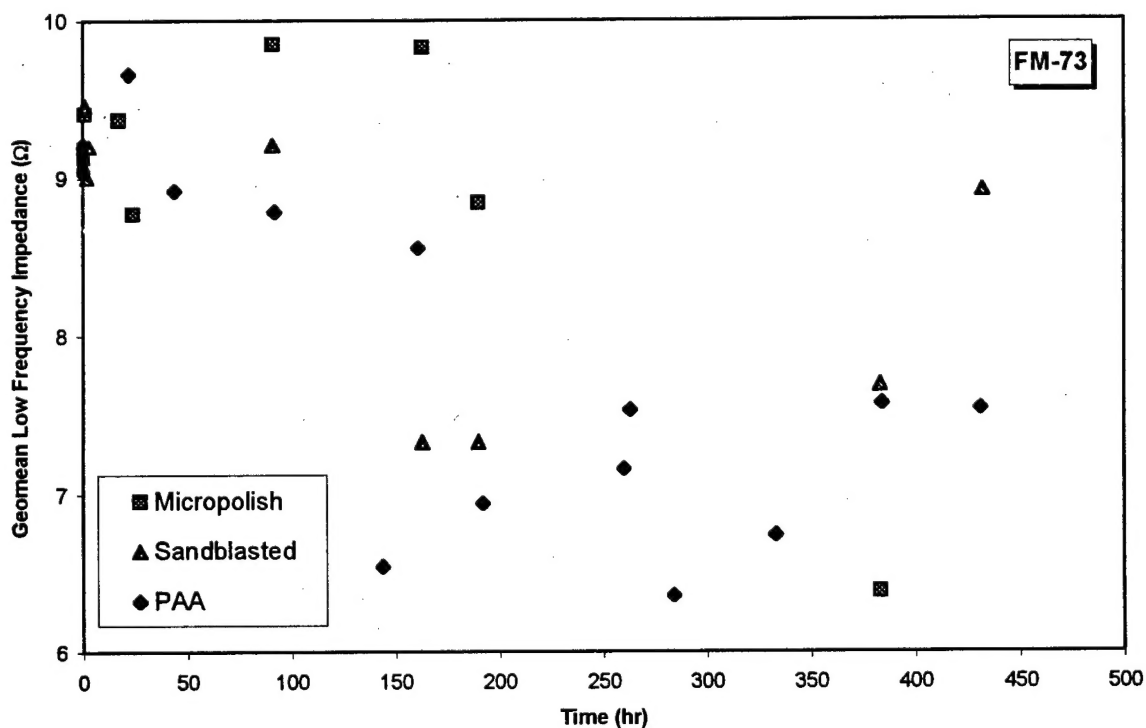
Figure 9. Geometric mean of the impedance over the lowest frequency decade for micropolished, sandblasted, and PAA aluminum wedge specimens using FM-73

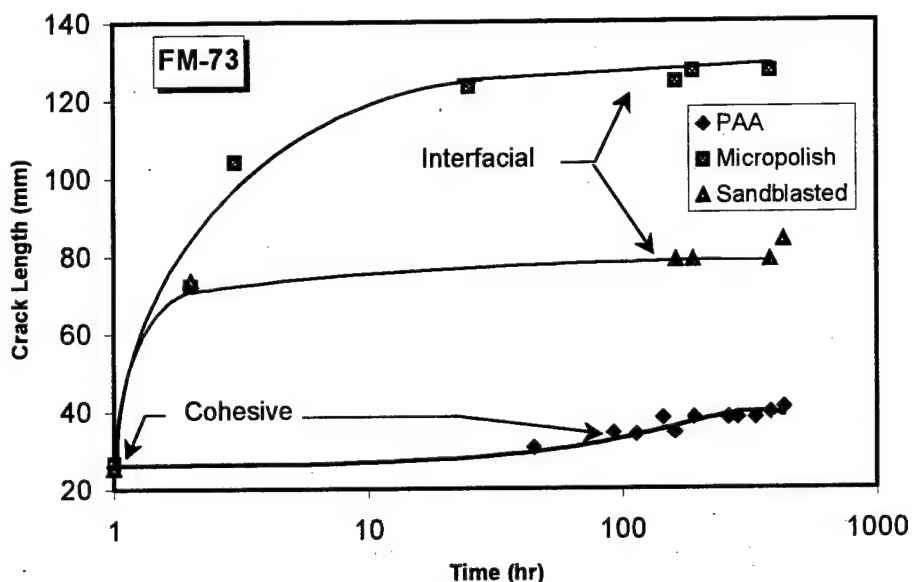
Crack length measurements are given in Figure 10. Two distinct behaviors are noted, depending on surface preparation. All start cohesively between the two FM-73 plies. The crack in the PAA specimens remains between the two adhesive films and only slowly propagates. Its interface remains stable under these conditions, as expected. The cracks for the other two treatments very quickly shift to the interface. The smooth interface of the micropolished adherends can withstand very little stress and the crack propagates almost to the end of the specimen upon exposure to humidity as the moisture disrupts the secondary interfacial forces. The sandblasted specimens are able to support some interfacial stress as a result of low-quality roughness and the crack rapidly advances to the point where the limiting stress is reached.

Figure 10. Crack length vs time for FM-73 wedge test specimens. The data represent two individual specimens.

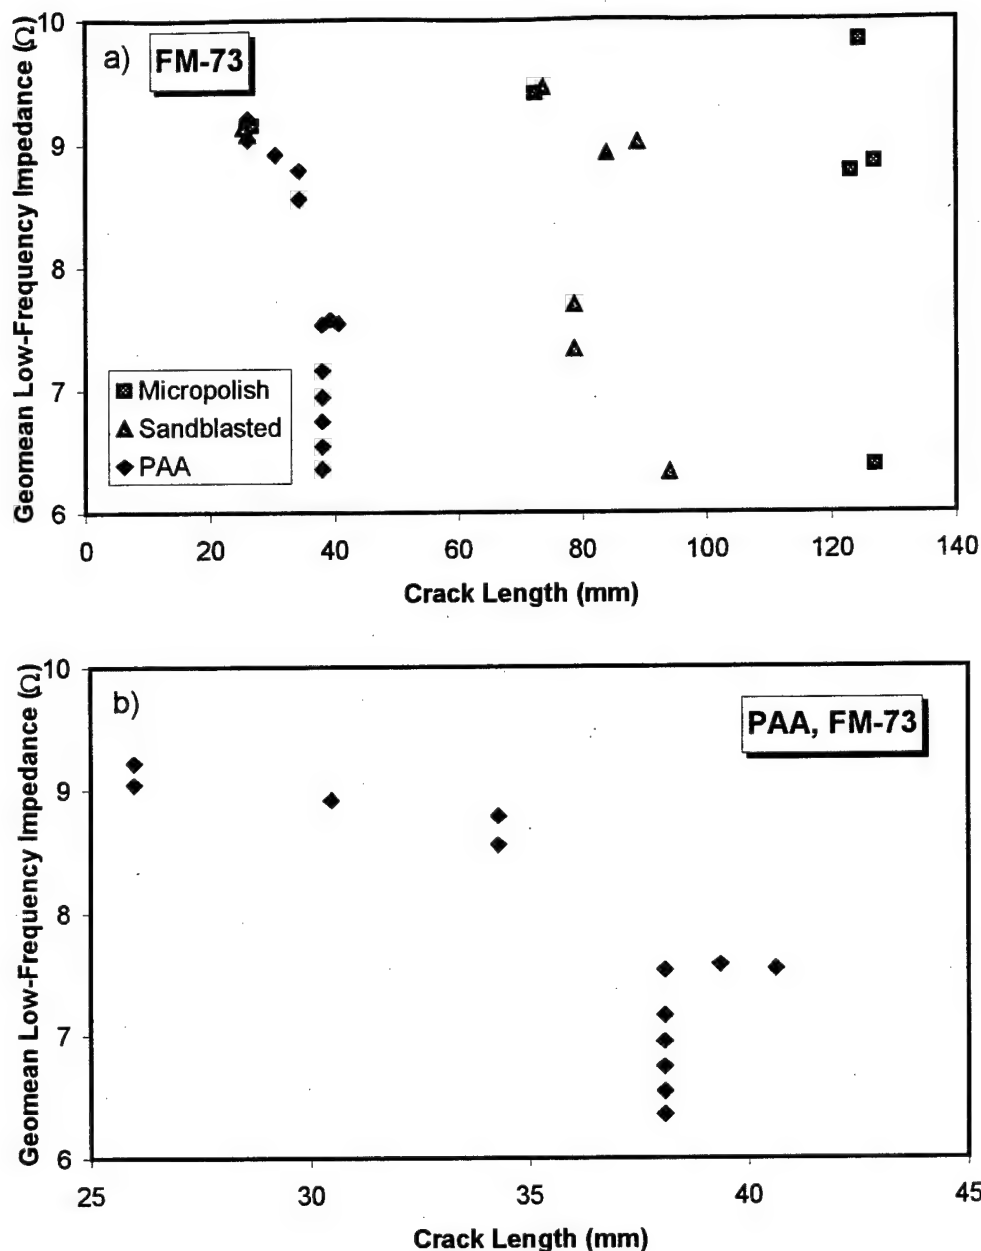
Comparing the EIS measurements with crack lengths shows two different types of correlations, depending on the locus of crack propagation (Figure 11). For sandblasted and micropolished specimens, for which the crack propagates interfacially, the initial, rapid crack growth occurs with minimal change in the low-frequency impedance. For these weak interfaces, the crack propagates as soon as moisture reaches the interface – before it has a chance to absorb into the bulk adhesive and change the impedance. Over time, this absorption occurs and the impedance decreases, but the crack has arrested or is growing very slowly as it reaches the point of sustainable stress. For the PAA specimens, the limiting factor governing crack propagation under these conditions and time is not the interface, but rather, it is the weakening of the adhesive due to moisture absorption. In this case, there is a distinct relationship between the low-frequency impedance (absorbed moisture) and crack growth until the crack arrests after approximately one centimeter of propagation. At that point, the adhesive continues to absorb moisture, but without additional crack growth.

Figure 11. Geometric mean of the low frequency impedance as a function of crack length for FM-73 adhesive. a) all three surface treatments; b) increased scale for PAA only.

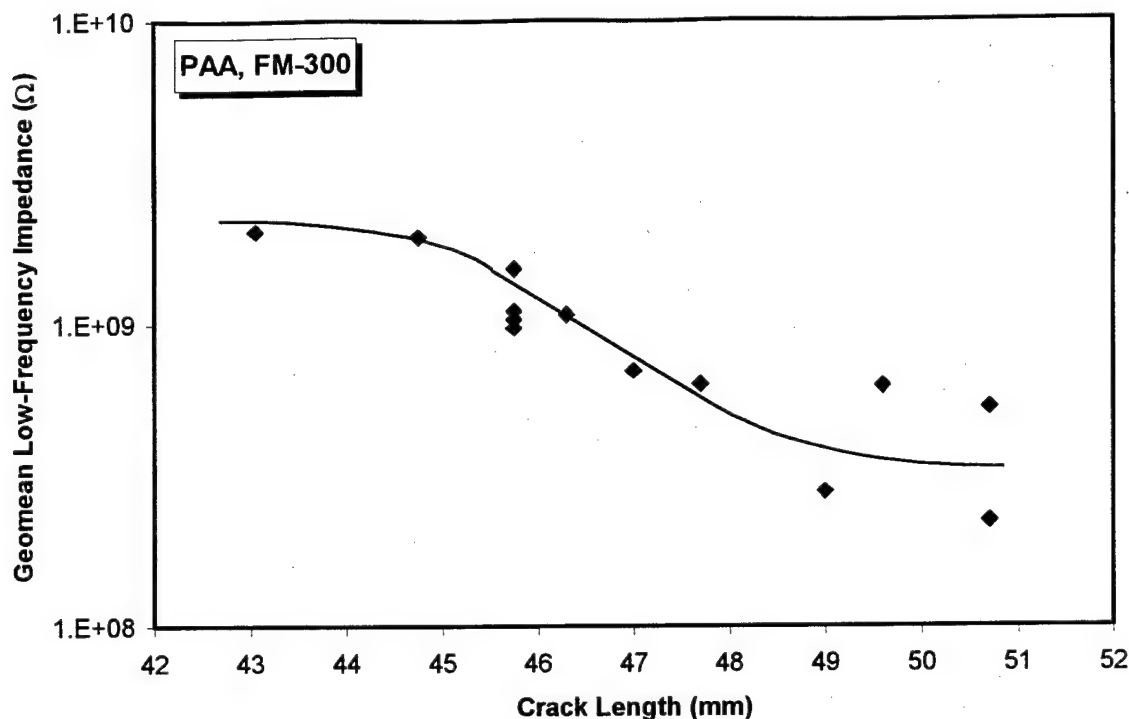
Similar results were obtained with wedge tests using FM-300 adhesive except that these specimens exhibit less moisture absorption by the adhesive and, hence, a smaller decrease in the low-frequency impedance of the EIS spectra. Again, the interfacial crack propagation of the sandblasted and micropolished specimens allowed crack growth before there was significant absorption of moisture by the adhesive. On the other hand, moisture absorption appeared to be a prime factor in crack propagation within the adhesive for the PAA specimens as reflected by the correlation in Figure 12.

Figure 12. Geometric mean of the low frequency impedance as a function of crack length for PAA specimens with FM-300 adhesive.

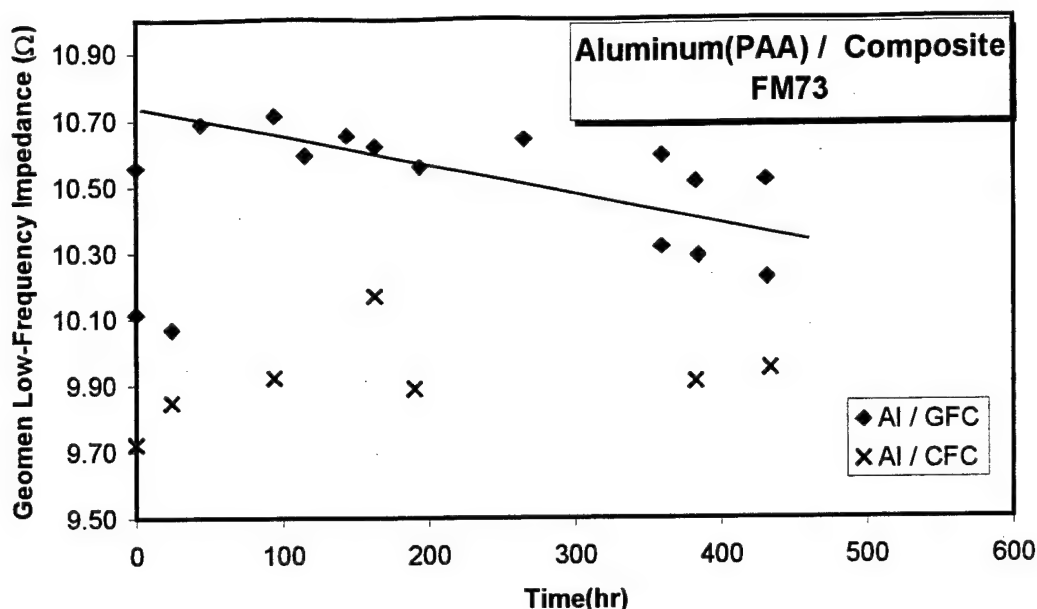
The EIS measurements reflect both the adhesive and the composite. The greater impedance of the GFC data (Figure 13) compared to that of the CFC data and that of the aluminum/aluminum data (Figure 9) indicate that the impedance of the glass composite is dominating over that of the adhesive. By comparison, the lower impedance (greater conductivity) of the graphite epoxy is evident. There is a small, but distinct trend for the impedance of the GFC specimens to decrease over time. We attribute this to absorption of moisture by the composite itself. Detection of moisture absorption in both GDC and CFC monolithic material has been previously reported using the *in-situ* sensors.²³ Based on the previous data, the amount of moisture absorbed by the GFC under these conditions is small, less than 1%. No indications of moisture absorption in the CFC is seen, but moisture detection in these materials has required equivalent circuit analysis which was not done in this case.

Figure 13. Geometric mean of the low-frequency impedance as a function of time for aluminum / glass fiber-reinforced composites and aluminum / carbon fiber-reinforced composites.

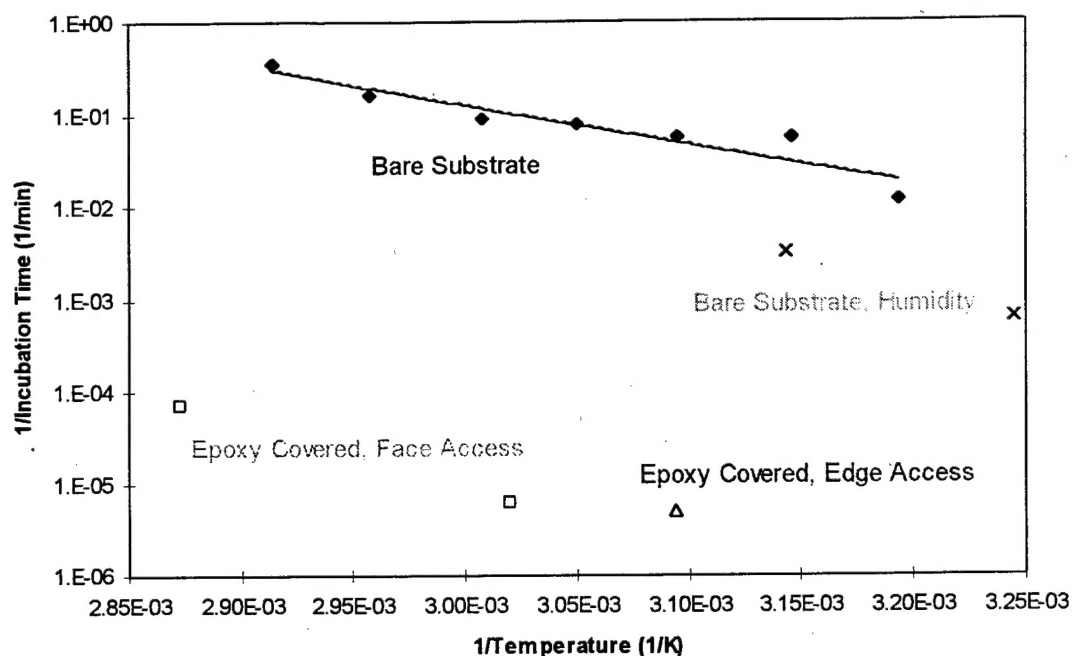
A comparison can be made for the times for hydration to occur, t_i , for FPL surfaces under different conditions. In this experiment where moisture had to diffuse from the edge of an adhesive, one specimen showed hydration beginning after 140 days; others showed no hydration after 120 and 135 days. The 140-day period represents a minimum value of the incubation time at 50°C under these conditions. For specimens covered with an epoxy adhesive, but with a free epoxy surface exposed to water at 58°C so that moisture only had to absorb through the thickness of the adhesive, Davis et al. found hydration beginning after approximately 110 days.¹⁵ At 75°C, the incubation time decreased to approximately 229 hours.²⁶ For bare specimens, the incubation time is much shorter. McNamara and Agoff found incubation times to range from 3 minutes at 70°C to 85 minutes at 40°C for immersion; for humidity, the times ranged from 5 hours at 45°C to 27 hours at 35°C.²⁷ These data are compiled on the Arrhenius plot of Figure 14 for the equation

$$1/t_i \propto k = Ae^{-E_a/RT}$$

Based on the immersed, bare substrates, the activation energy, E_a , which is proportional to the slope, is calculated to be 82 kJ/mole. This value compares well to that determined by Alwitt of 78 kJ/mole for hydration of the amorphous oxide on pure Al.²⁸ Within the accuracy of the limited data, the activation energy for hydration is the same for each condition, as expected for similar surfaces. Although not available from the data reported here, the activation energy for hydration of a PAA surface would be much higher so that the incubation time would be much longer for identical conditions. Previous experiments indicate that the incubation time for PAA surfaces is approximately two orders of magnitude longer than that for FPL surfaces.²⁹ Accordingly, it is not surprising that we did not detect any hydration of the PAA tensile-button specimens during our testing.

Figure 14. Arrhenius plot of incubation times prior to hydration of FPL aluminum under various conditions. The bare substrate data are from Ref. 27; the epoxy covered, face access data are from Refs. 15 and 26; the epoxy covered, edge access datum is from the current work.
